TECHNICAL REPORT M-361
September 1984

Lightweight Relocatable Structures for the Theater of Operations

**FIELD TESTING OF A LIGHTWEIGHT RELOCATABLE
STRUCTURE IN A DESERT ENVIRONMENT**

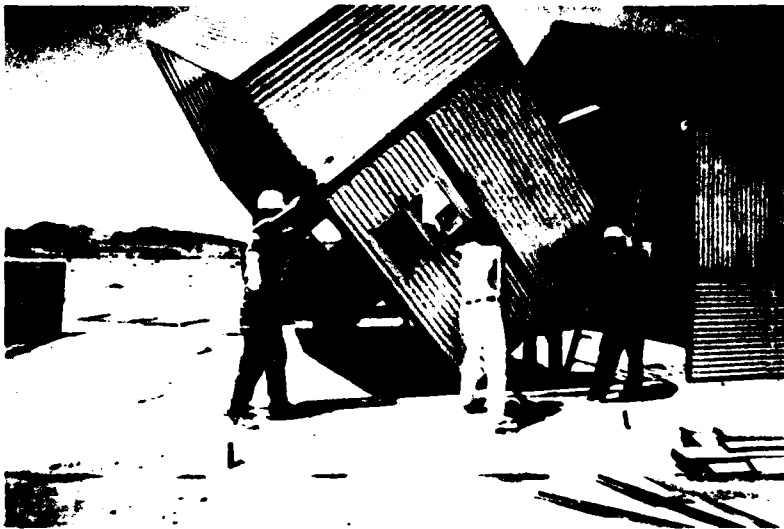
Figure 31. Sequence of erection of the 12-ft galvanized building with a crane.

Since manually erecting the endwall was hazardous, the construction was temporarily delayed until a crane could be used. Even with a crane, the process was relatively slow. It took time to guide the sections to their correct positions on the baseplate and to stabilize them until they could be anchored (Figure 31). The sections were keyed together and lag-bolted to the baseplate in the same way as for the control building. Guy wires were added to every other section to support the building laterally.
